**Flood Control Project Maintenance
Levee Inspections**

Maintenance Issue Types Only, Levee Inspection Report By Mile - Fall 2014

Reclamation District No. 0817 Carlin

Waterway	Bank	Unit Miles	Inspection Start/End	Inspector
Unit No. 01 South Dry Creek	Left	3.81	10/16/2014 10/16/2014	Matthew Hoffman

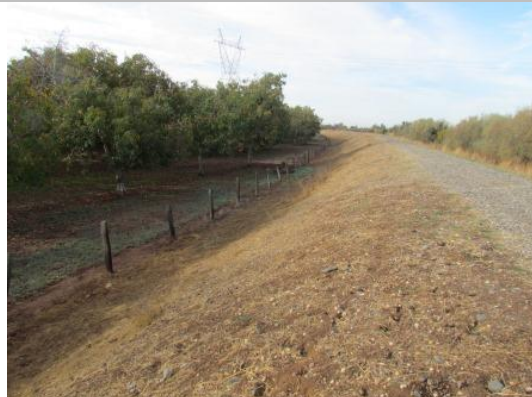
Photo 1 of 1 : FA_2014_RD0817_12_2_20141017_00005.jpg

LM Start	2.10	Rating **	A	Issue No.	2
LM End	2.10	Issue Type +	Ma	Location *	LS
Category	Earthen Levee			GPS Latitude/Longitude	
				Start	End
Item	Vegetation			39.007115 °	39.007115 °
				-121.481094 °	-121.481094 °
DWR ID	DWR_RD0817_01_f_2014_2				
Action/Comments					
Control annual grass and weeds on the levee slopes and easements.

This photo was taken from the crown facing west looking down the landward levee slope at acceptable vegetation maintenance. Fall 2014.

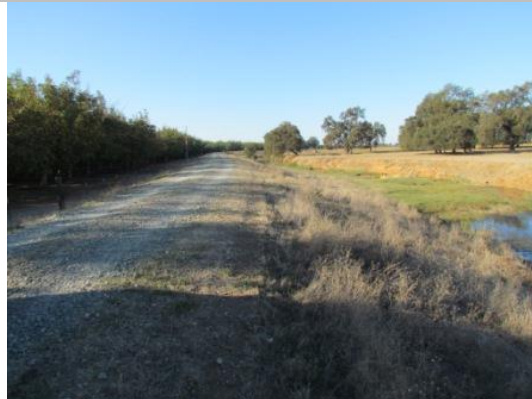
Photo 1 of 1 : FA_2014_RD0817_12_7_20141013_00001.jpg

LM Start	2.42	Rating **	A/W	Issue No.	7
LM End	3.75	Issue Type +	Ma	Location *	WS
Category	Earthen Levee			GPS Latitude/Longitude	
				Start	End
Item	Vegetation			39.009167 °	39.019369 °
				-121.475814 °	-121.455139 °
DWR ID	DWR_RD0817_01_f_2013_7				
Action/Comments					
Remove the wild growth other than native grasses from the levee slopes.

This photo was taken from the crown of the levee facing west looking at the vegetation on the waterward side of the levee.

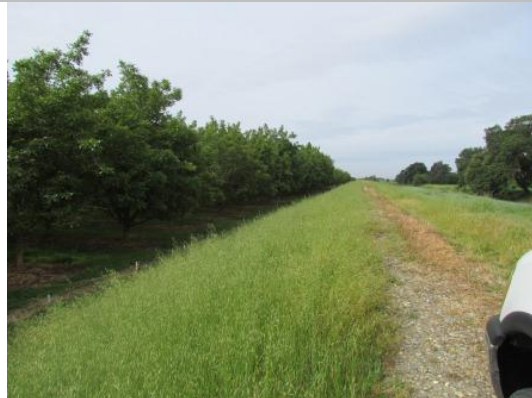
Photo 1 of 1 : FA_2014_RD0817_12_11_20141013_00003.jpg

LM Start	2.42	Rating **	A/W	Issue No.	11
LM End	3.75	Issue Type +	Ma	Location *	LS
Category	Earthen Levee			GPS Latitude/Longitude	
				Start	End
Item	Vegetation			38.984695 °	39.019369 °
				-121.506115 °	-121.455139 °
DWR ID	DWR_RD0817_01_f_2013_11				
Action/Comments					
Remove the wild growth other than native grasses from the levee slopes.

This photo was taken from the levee crown facing west looking down the landward levee slope at vegetation requiring maintenance. Spring 2014.

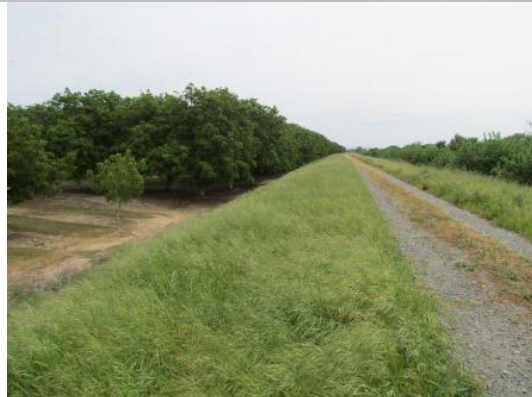
Photo 1 of 1 : FA_2014_RD0817_13_5_20141013_00001.jpg

LM Start	0.01	Rating **	A/W	Issue No.	5
LM End	1.19	Issue Type +	Ma	Location *	LS
Category	Earthen Levee			GPS Latitude/Longitude	
				Start	End
Item	Vegetation			38.984502 °	38.985971 °
				-121.505957 °	-121.484564 °
DWR ID	DWR_RD0817_02_f_2012_5				
Action/Comments					
Remove the wild growth other than native grasses from the levee slopes.

This photo was taken from the levee crown facing east looking down the landward levee slope at vegetation requiring maintenance. Spring 2014.

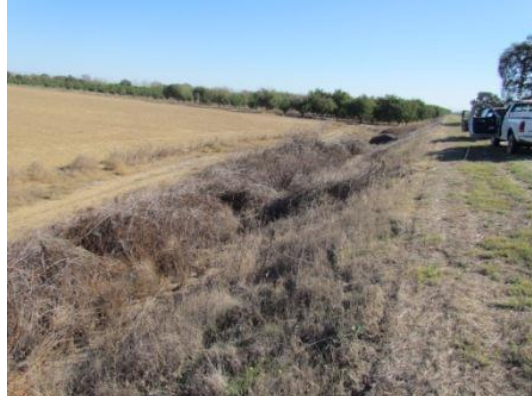
Photo 1 of 1 : FA_2014_RD0817_13_9_20141013_00003.jpg

LM Start	0.27	Rating **	U	Issue No.	9
LM End	0.27	Issue Type +	Ma	Location *	LS
Category	Earthen Levee			GPS Latitude/Longitude	
				Start	End
Item	Vegetation			38.984308 °	38.984308 °
				-121.501561 °	-121.501561 °
DWR ID	DWR_RD0817_02_f_2013_9				
Action/Comments					
Remove the wild growth other than native grasses from the levee slopes.					
Inspector Comments: Berry bushes have been sprayed but still need to be removed.

This photo was taken from the crown of the levee facing east looking at the blackberry bushes on the landward slope of the levee. They have been sprayed but still need to be removed.

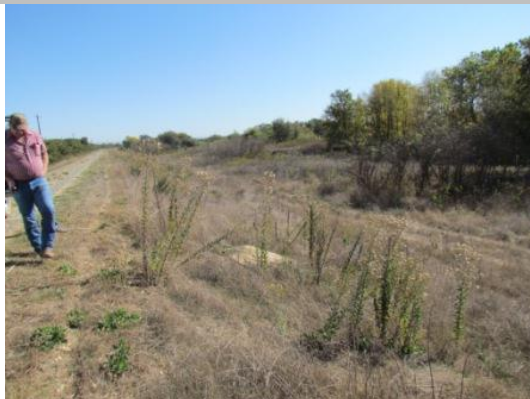
Photo 1 of 1 : FA_2014_RD0817_13_14_20141013_00006.jpg

LM Start	2.17	Rating **	U	Issue No.	14
LM End	2.17	Issue Type +	Ma	Location *	WS
Category	Earthen Levee			GPS Latitude/Longitude	
				Start	End
Item	Animal Control			38.989727 °	38.989727 °
				-121.467162 °	-121.467162 °
DWR ID	DWR_RD0817_02_f_2013_14				
Action/Comments					
Exterminate rodents and backfill and compact or grout burrows. Inspector Comments: Medium sized animal burrow in the the waterward side of the levee slope.

This photo was taken from the crown of the levee facing east looking at a medium sized animal burrow in the the waterward side of the levee slope.

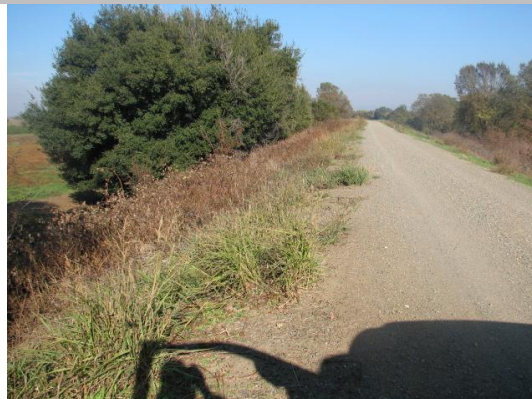
Photo 1 of 1 : FA_2014_RD0784_183_8_20140929_00001.jpg

LM Start	0.54	Rating **	U	Issue No.	8
LM End	0.79	Issue Type +	Ma	Location *	LS
Category	Earthen Levee			GPS Latitude/Longitude	
				Start	End
Item	Vegetation			38.989961 °	38.992220 °
				-121.502009 °	-121.498198 °
DWR ID	DWR_RD0784_06_f_2012_8				
Action/Comments					
Remove the wild growth other than native grasses from the levee slopes.					
Inspector Comments: Dense berry bushes along lower slope.

Levee mile 0.54, the landside slope.

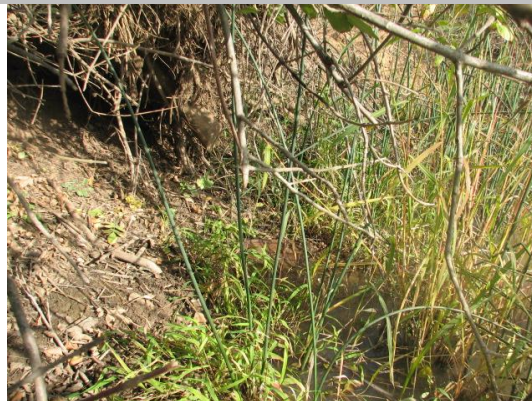
Photo 1 of 3 : FA_2014_RD0784_183_11_20140929_00004.jpg

LM Start	0.68	Rating **	U	Issue No.	11
LM End	0.68	Issue Type +	Ma	Location *	WS
Category	Interior Drainage & Piping Systems			GPS Latitude/Longitude	
				Start	End
Item	Culverts: Breaks / Holes / Cracks			38.991084 °	38.991084 °
				-121.499871 °	-121.499871 °
DWR ID	DWR_RD0784_06_f_2012_11				
Action/Comments

Levee mile 0.68, this is located near the low flow channel, the flap gate is lying on the ground, the end of the pipe was not located.

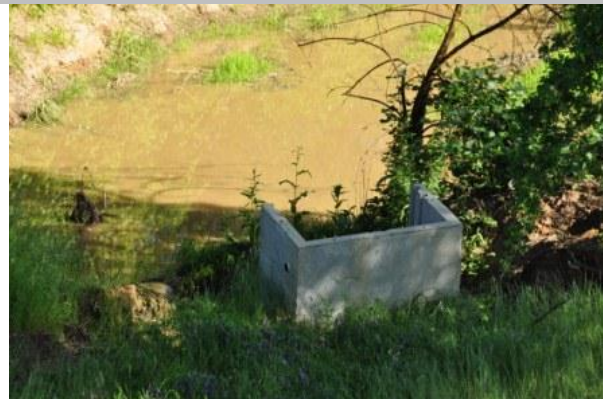
Photo 2 of 3 : FA_2014_RD0784_183_11_20140929_00005.jpg

LM Start	0.68	Rating **	U	Issue No.	11 (cont)
LM End	0.68	Issue Type +	Ma	Location *	WS
Category	Interior Drainage & Piping Systems			GPS Latitude/Longitude	
				Start	End
Item	Culverts: Breaks / Holes / Cracks			38.991084 °	38.991084 °
				-121.499871 °	-121.499871 °
DWR ID	DWR_RD0784_06_f_2012_11				
Action/Comments

L/S Intake at LM 0.68

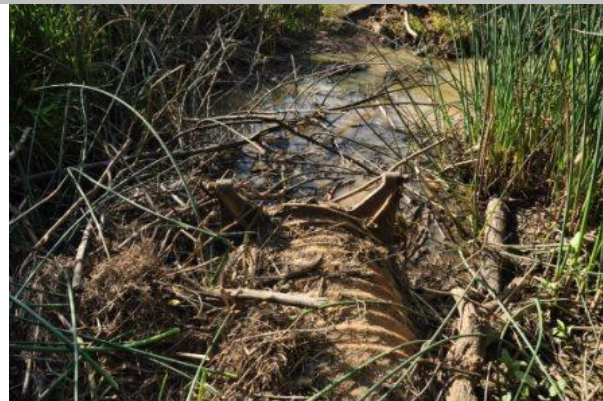
Photo 3 of 3 : FA_2014_RD0784_183_11_20140929_00006.jpg

LM Start	0.68	Rating **	U	Issue No.	11 (cont)
LM End	0.68	Issue Type +	Ma	Location *	WS

CMP is rusting and has numerous holes but flap gate is in place.
4/25/13 - Burnett

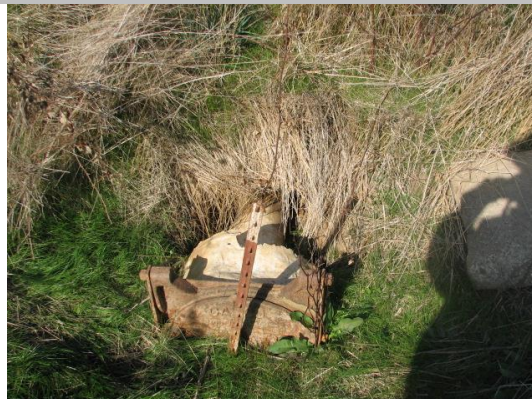
Photo 1 of 1 : FA_2014_RD0784_183_10_20140929_00003.jpg

LM Start	1.17	Rating **	U	Issue No.	10
LM End	1.17	Issue Type +	Ma	Location *	WS
Category	Interior Drainage & Piping Systems			GPS Latitude/Longitude	
				Start	End
Item	Culverts: Breaks / Holes / Cracks			38.995856 °	38.995856 °
				-121.493110 °	-121.493110 °
DWR ID	DWR_RD0784_06_f_2012_10				
Action/Comments

Levee mile 1.17 near the low flow channel, it appears a smaller pipe has been sleeved into the larger pipe, the flap gate does not make contact with the smaller pipe.

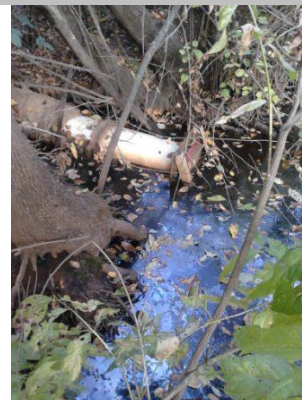
Photo 1 of 1 : FA_2014_RD0784_183_16_20140929_00009.jpg

LM Start	1.26	Rating **	M	Issue No.	16
LM End	1.33	Issue Type +	Ma	Location *	WS
Category	Interior Drainage & Piping Systems			GPS Latitude/Longitude	
				Start	End
Item	Culverts: Inlets / Outlets				°
					°
DWR ID	DWR_RD0784_06_f_2012_16				
Action/Comments

Levee mile 1.33 waterside of the levee, this pipe appears to be sleeved into a larger pipe, access to both ends is limited.

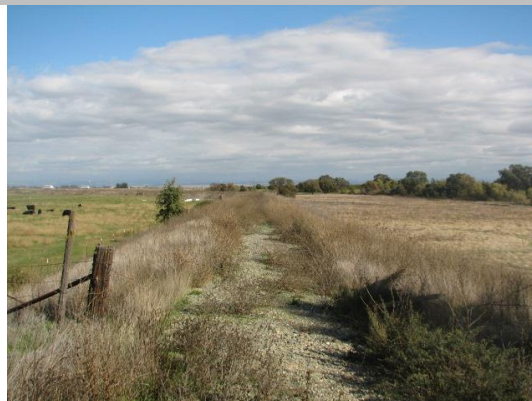
Photo 1 of 1 : FA_2014_RD0784_183_14_20140929_00007.jpg

LM Start	1.27	Rating **	U	Issue No.	14
LM End	1.50	Issue Type +	Ma	Location *	CR
Category	Earthen Levee			GPS Latitude/Longitude	
				Start	End
Item	Vegetation			38.997019 °	38.999719 °
				-121.491802 °	-121.490147 °
DWR ID	DWR_RD0784_06_f_2012_14				
Action/Comments					
Remove the wild growth other than native grasses from the levee slopes.

Levee mile 1.27 looking upstream, typical of the levee from 1.27 to 1.50.
